Interim Report n°2

on the accident on **1st June 2009**
to the **Airbus A330-203**
registered **F-GZCP**
operated by **Air France**
flight AF 447 Rio de Janeiro – Paris

BEA

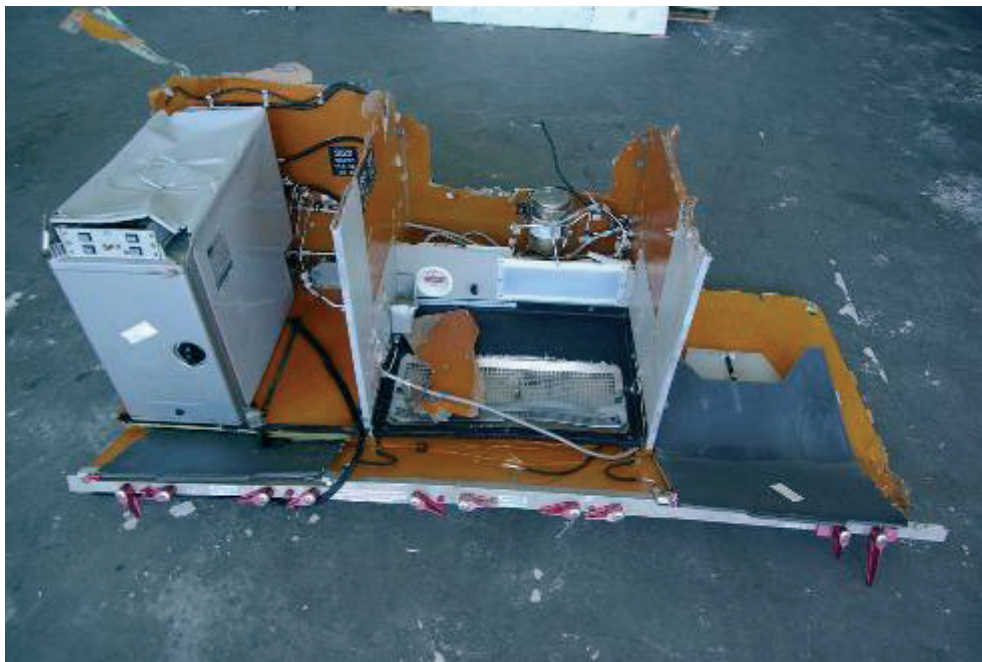
Part of Galley G3: downwards deformation at the level of the galley's heavy parts

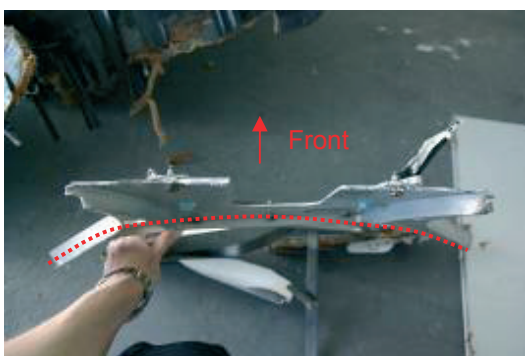
Certain overhead luggage racks were found with their fuselage attachment fittings. Besides the damage due to the vertical compression, these fittings have deformations that are due to a forward movement of the overhead luggage racks.

Luggage rack fitting deformed towards the front

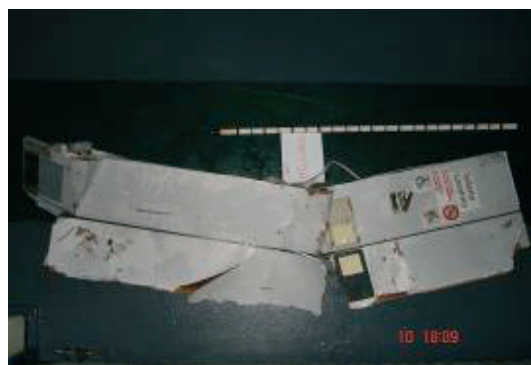
Toilet door (L54) metallic stiffeners deformed by buckling

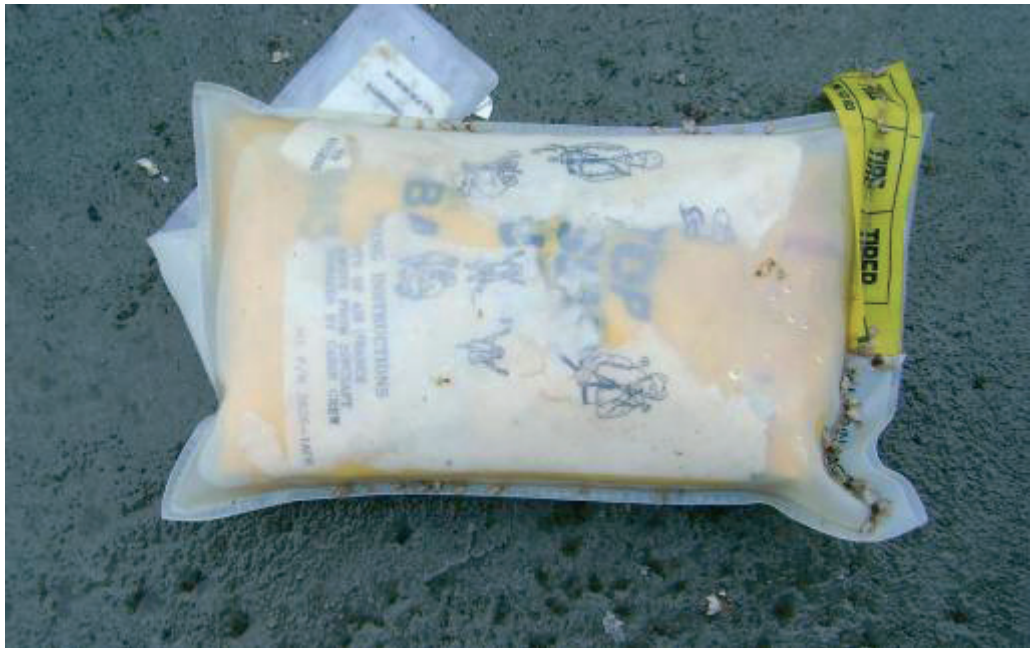
- The lifejackets that were found were all in their packaging.

Lifejacket found in its packaging

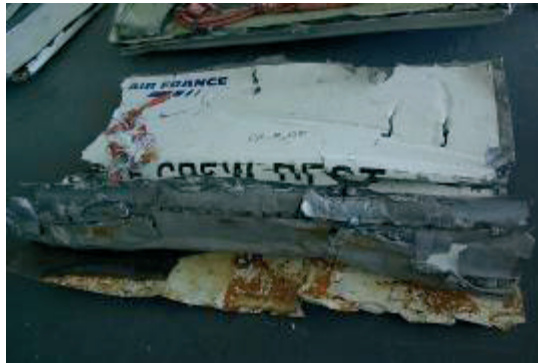
Part of the crumpled aft wall

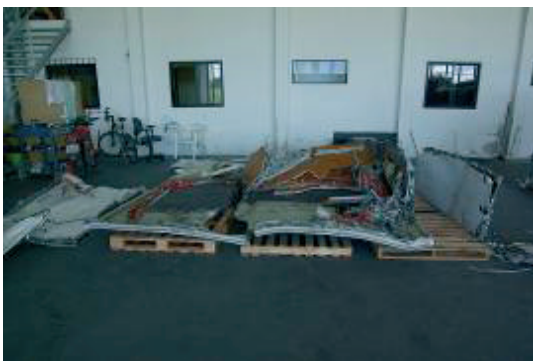
Floor of the LDMCR:
with bottom-upwards deformation

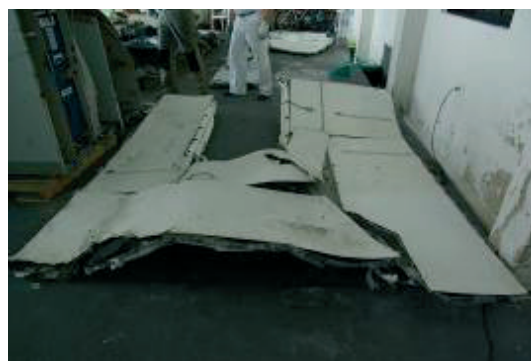
Ceiling of the LDMCR:
with top-downwards deformation

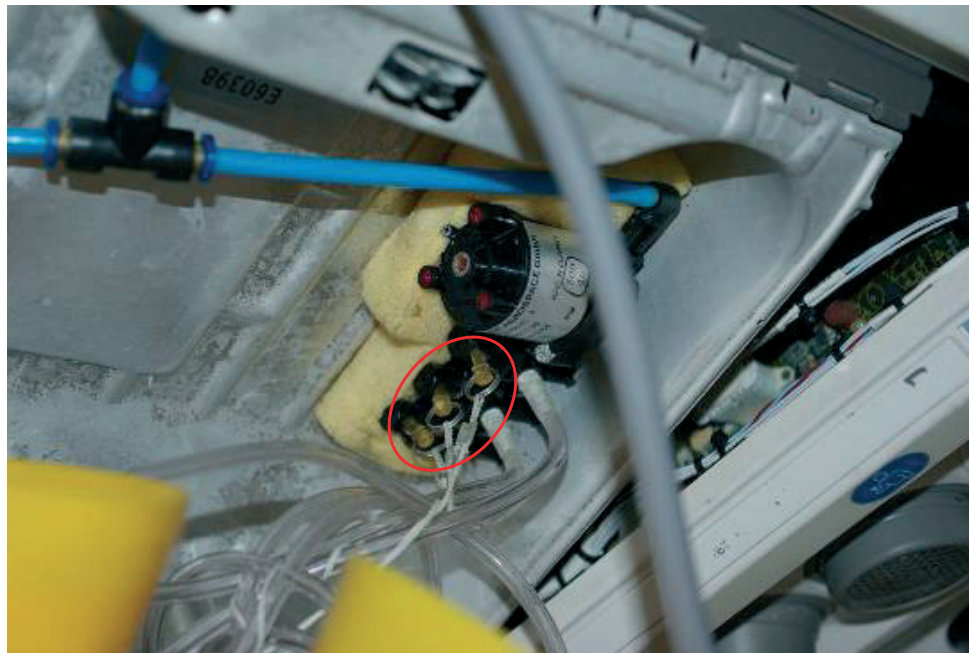
Passenger oxygen container recovered open: the three pins are in place

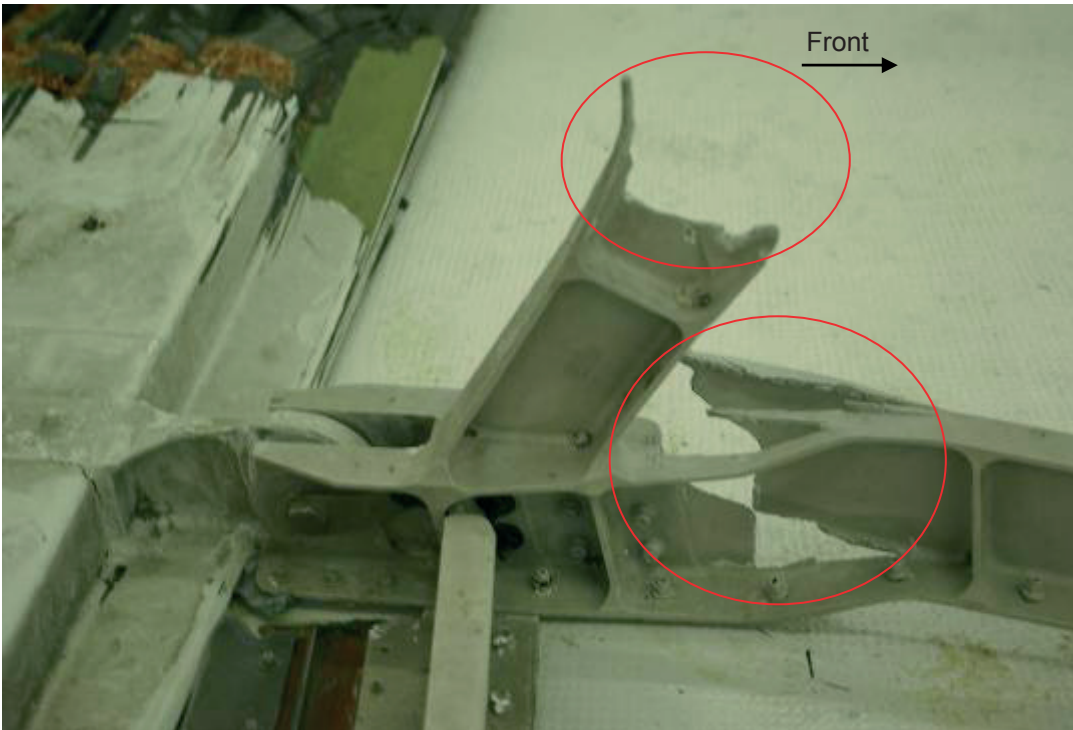
On the left-hand spoiler No. 1 and left-hand inboard aileron, certain fittings attaching the moving part to the wing aft spar were still present. The failures observed on these fittings were the result of the bottom-upwards loads applied on the spoiler or aileron.

Lower surface of left-hand spoiler No. 1 with a piece of the fitting attaching spoiler No. 5 to the wing aft spar: failures due to the bottom-upward loads on the spoiler

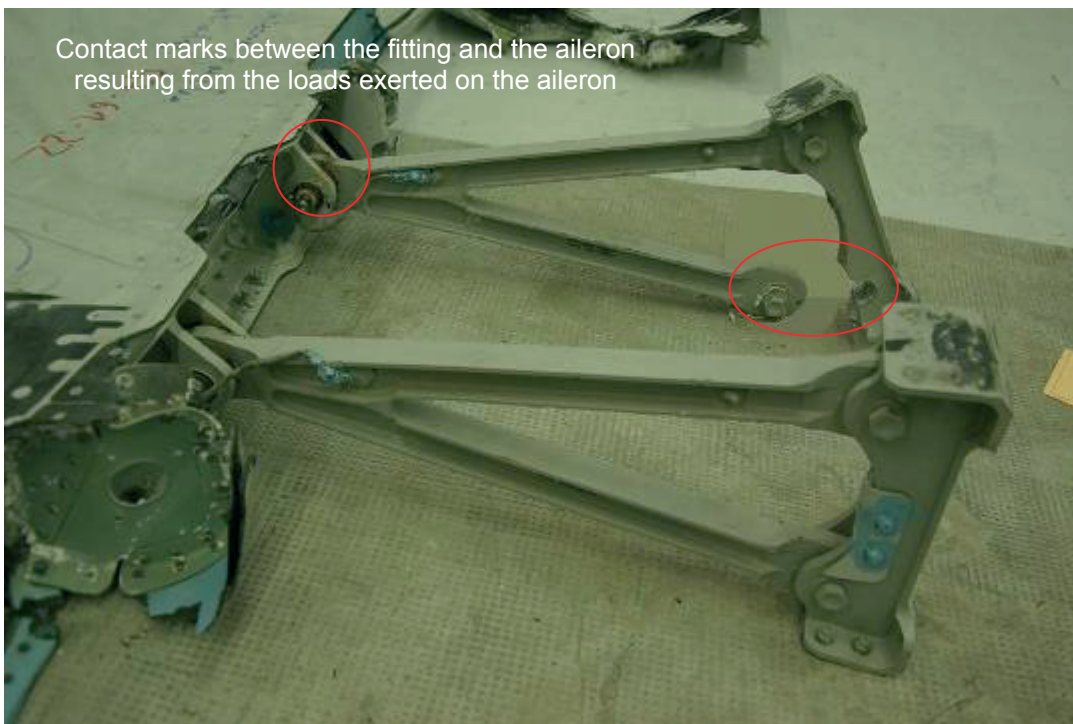
Contact marks between the fitting and the aileron resulting from the loads exerted on the aileron

Upper surface of the left-hand inboard aileron with the fittings attaching it to the wing aft spar: failure due to the bottom-upward loads applied on the aileron

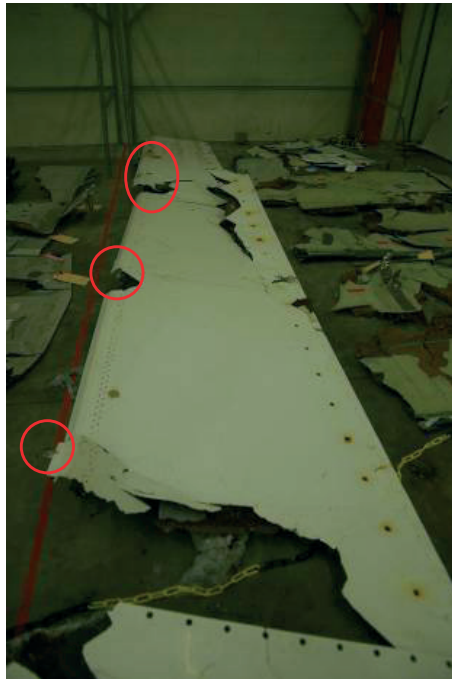
On the right-hand half elevator, four of the seven fittings attaching the elevator to the trimmable horizontal stabiliser were present. They had bottom-upwards deformations.

Outboard half of the right-hand elevator: the four attachments that can be seen were deformed bottom-upwards

From these observations it can be seen that the general direction of the loads that caused these deformations is bottom-upwards.

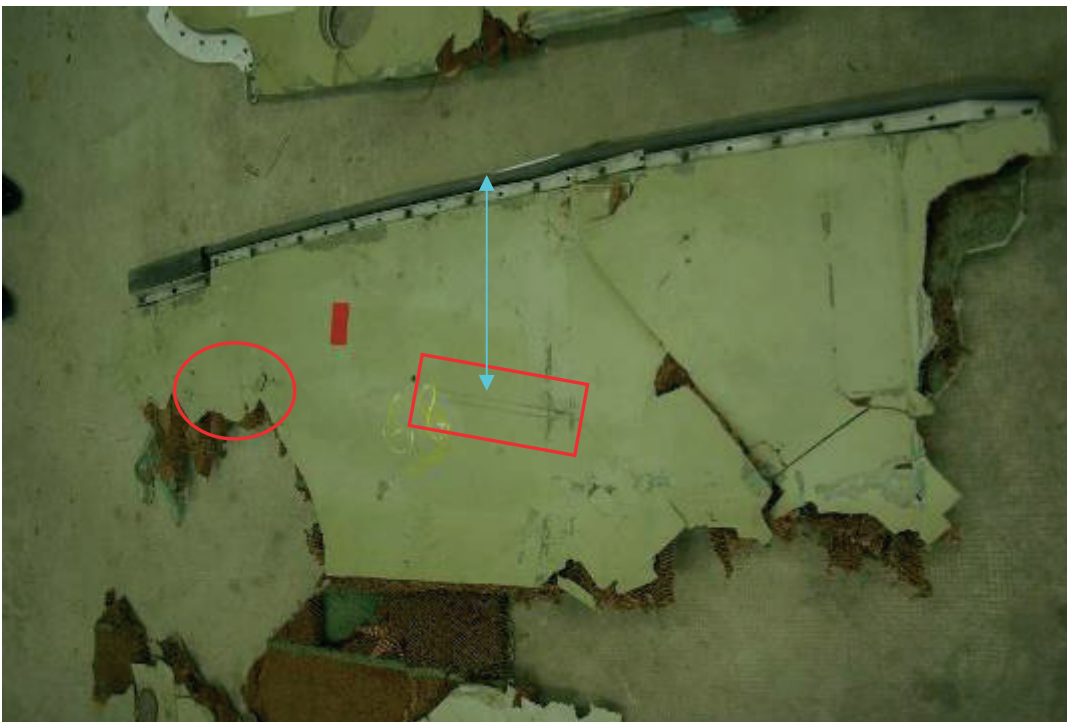
Several parts of the flap extension mechanism fairing were found. There were marks on two of them (positioned at the level of flap track No. 3), made by the flap extension track on impact. Analysis of these marks (morphological and dimensional examinations) and comparison with an identical aircraft made it possible to determine that the flaps were in the "retracted" position at the time of impact with the water (measurement of the distance between the track and the lower surface of the flap, position of the carriage on the track).

Part of the No. 3 flap track fairing on the left wing

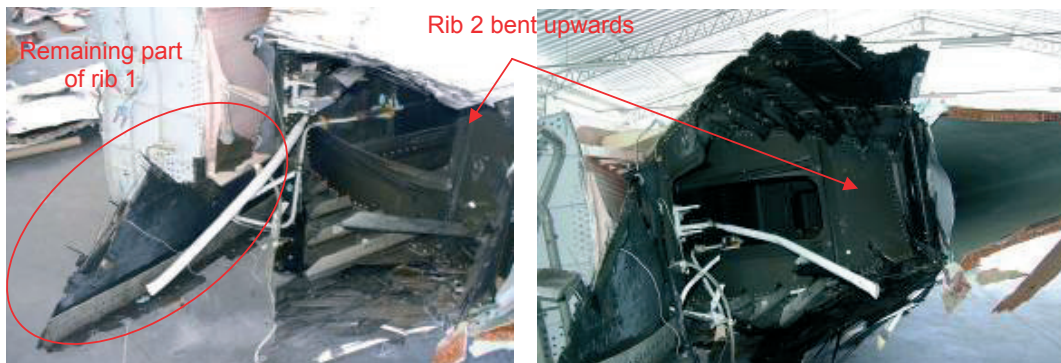
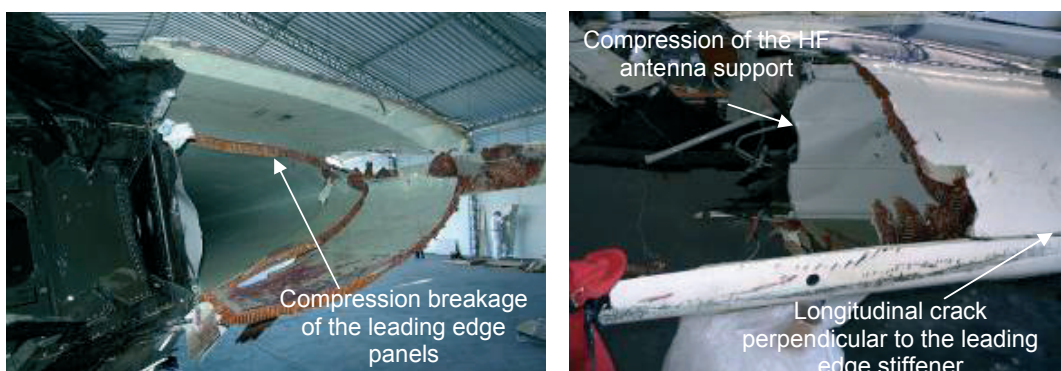
The front of the fin showed signs of symmetrical compression damage:

- ❑ failure of the leading edge right- and left-hand panels
- ❑ longitudinal cracking of the leading edge stiffener
- ❑ HF antenna support (attached to the forward spar): failure of the lower part, crumpling indicating bottom-upwards compression loads

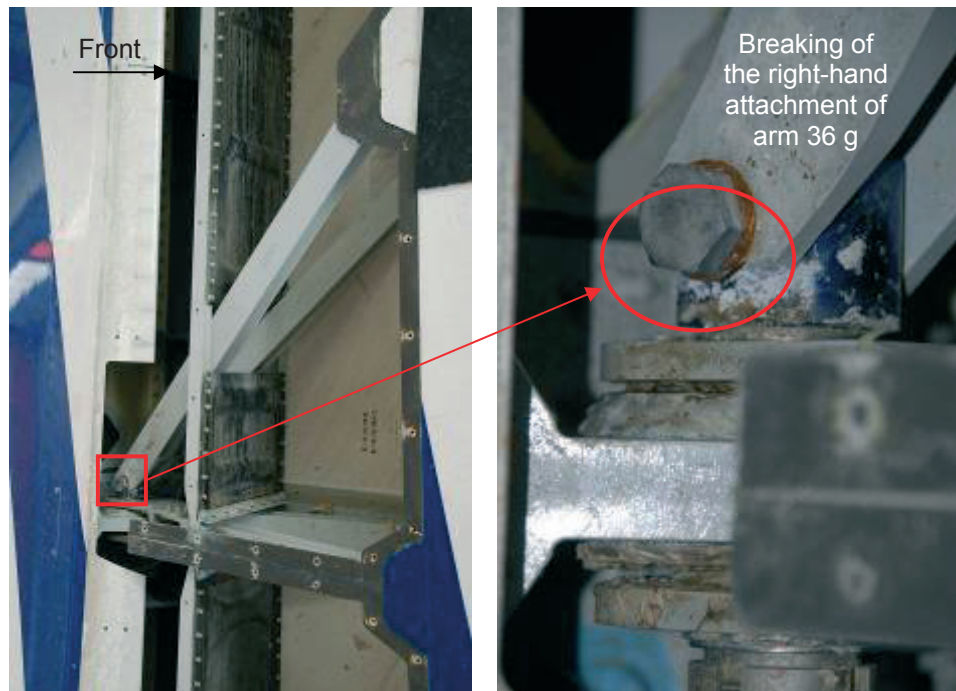
Arm 36 g, right view: failure of the rudder attachments

Shear cracks, along a top-down axis, can also be seen on the rudder hinge arm attachment fittings close to arm 36 g.

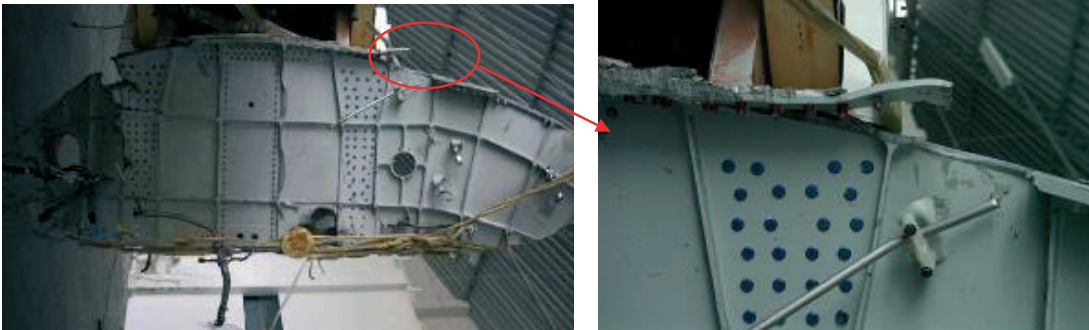
The fuselage was sheared along the frames and centre and aft attachment lugs by loads applied bottom-upwards.

Frame 87: shearing of the frame and fuselage skin along the frame

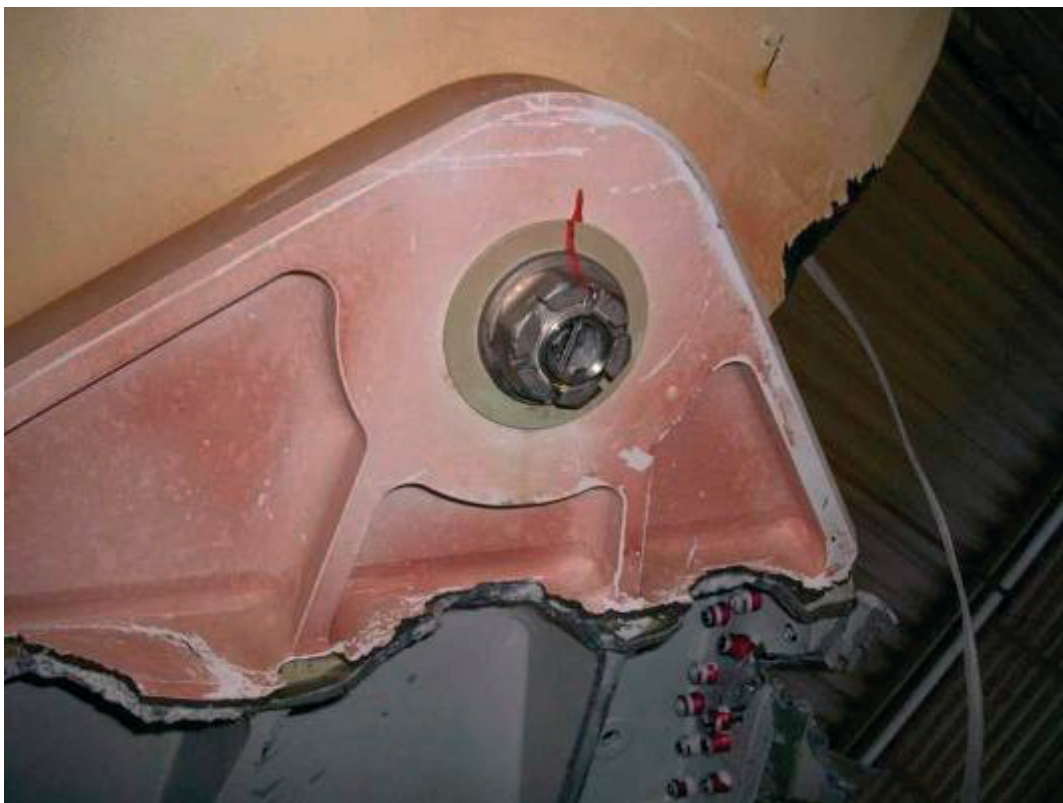
Right-hand aft lug: shearing of the fuselage along main frames 86-87

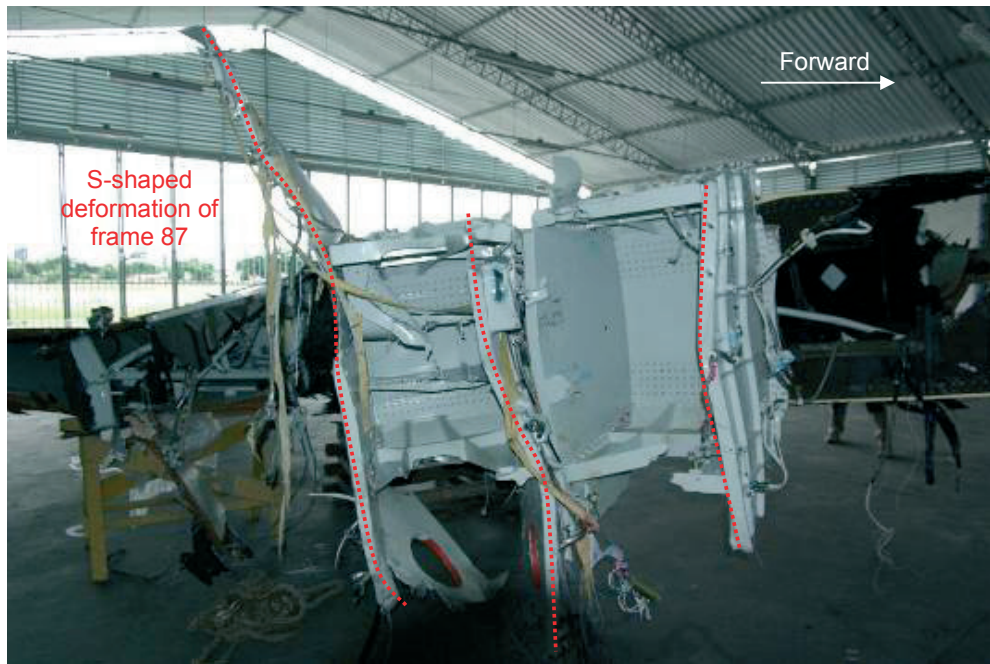
The part of frame 87 that can be seen had undergone S-shaped deformation: the left-hand side forwards, and the right-hand side backwards. The horizontal stabiliser actuator supports were deformed and broke in a backwards movement from the front. These observations indicate a backwards movement of the trimmable horizontal stabiliser.

Frames 84 to 87: S-shaped deformation of frame 87, with frames 84 and 85 pushed in backwards

The deformations of the frames were probably the consequence of the water braking the aircraft's forward movement.

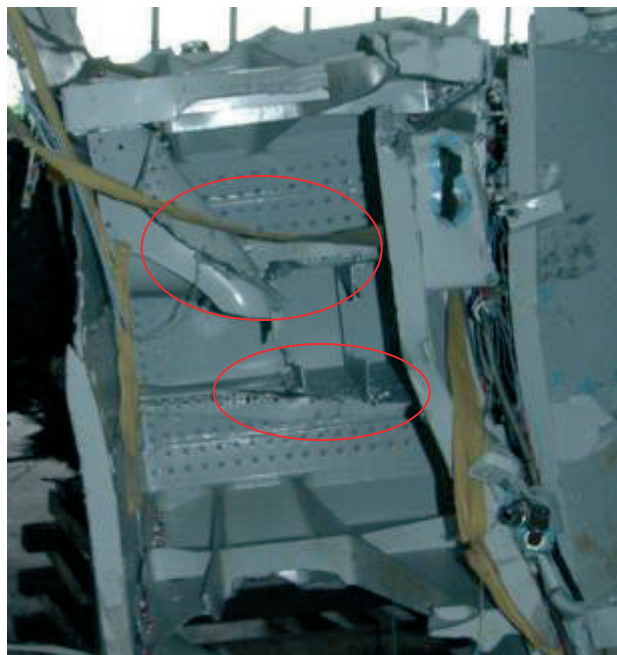
Frames 86 and 87: failure of the horizontal stabiliser actuator supports

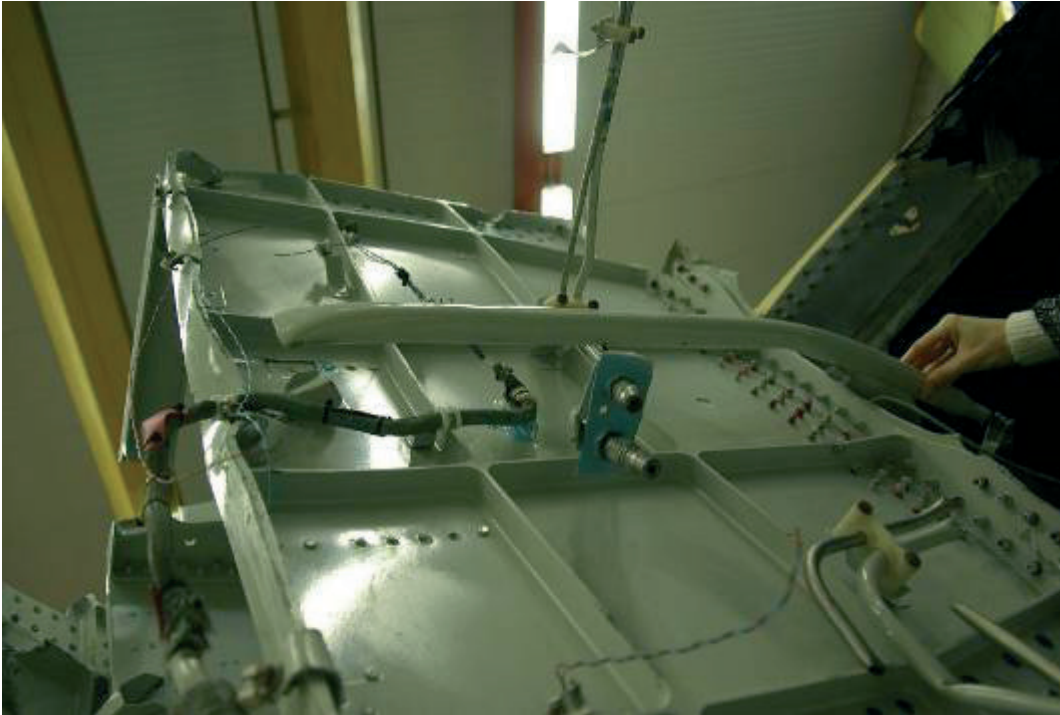
Frames 84 and 85 were pushed in backwards in the middle. The deformations observed on the rudder control rod are consistent with this indentation.

Deformations of the rudder control rod consistent with the backwards indentation of frame 84

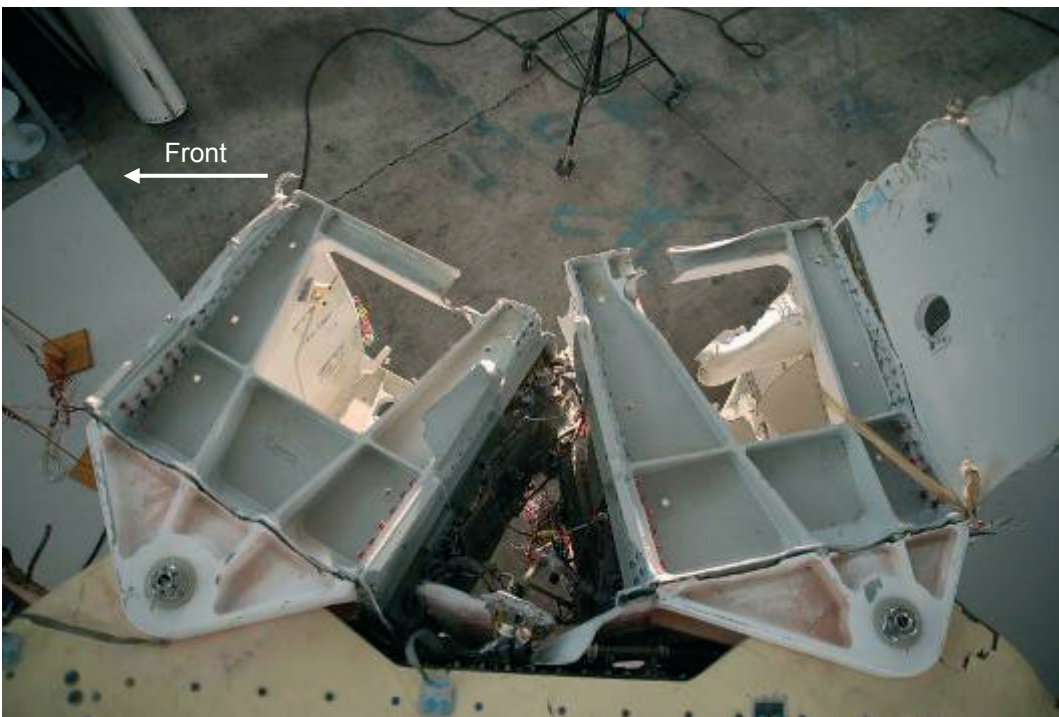
The centre attachment had pivoted backwards with the parts of the frames and web frames that were attached to it. The aft attachment had pivoted forwards with the parts of the frames and web frames that were attached to it.

Fin centre and aft attachments

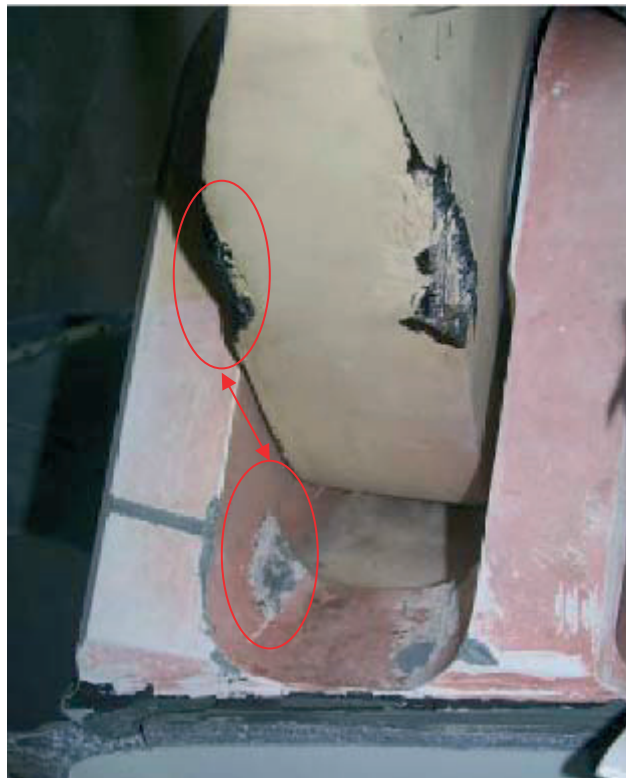
The aft attachment lugs (male on the fin and female on the airframe) had marks indicating a backwards movement of frames 86 and 87 as a whole.

Rear view of the left-hand aft lug: there were marks showing a backwards pivoting of frames 86 and 87

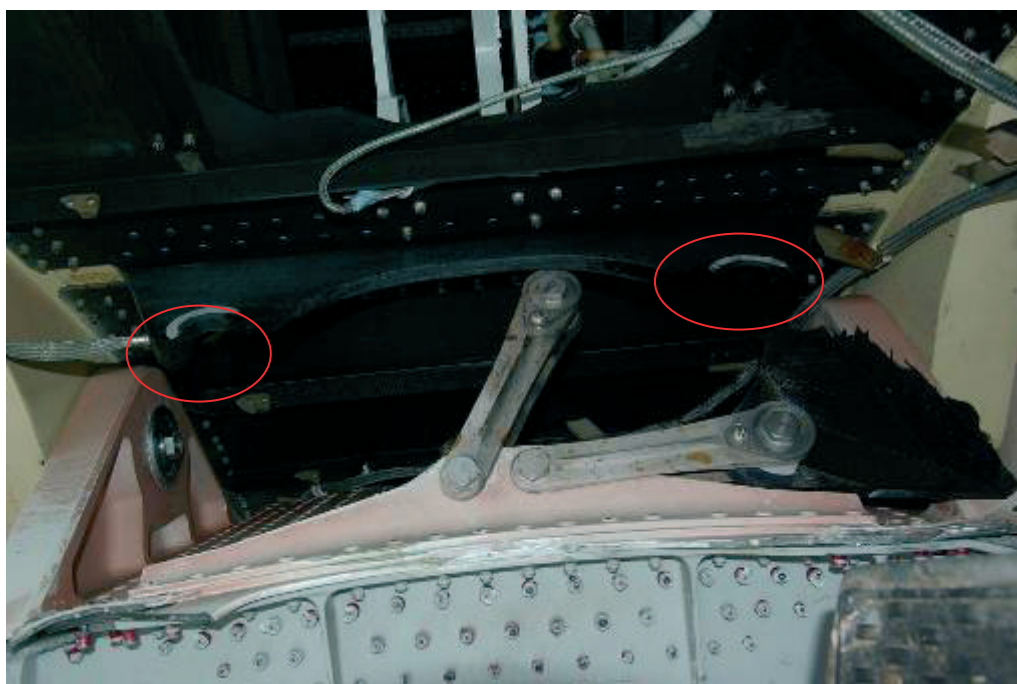
The centre and aft lateral load pick-up rods showed damage that was consistent with this backwards pivoting of frames 84 to 87:

Tensile failure of the centre spar at the level of the attachment of the lateral load pick-up rods

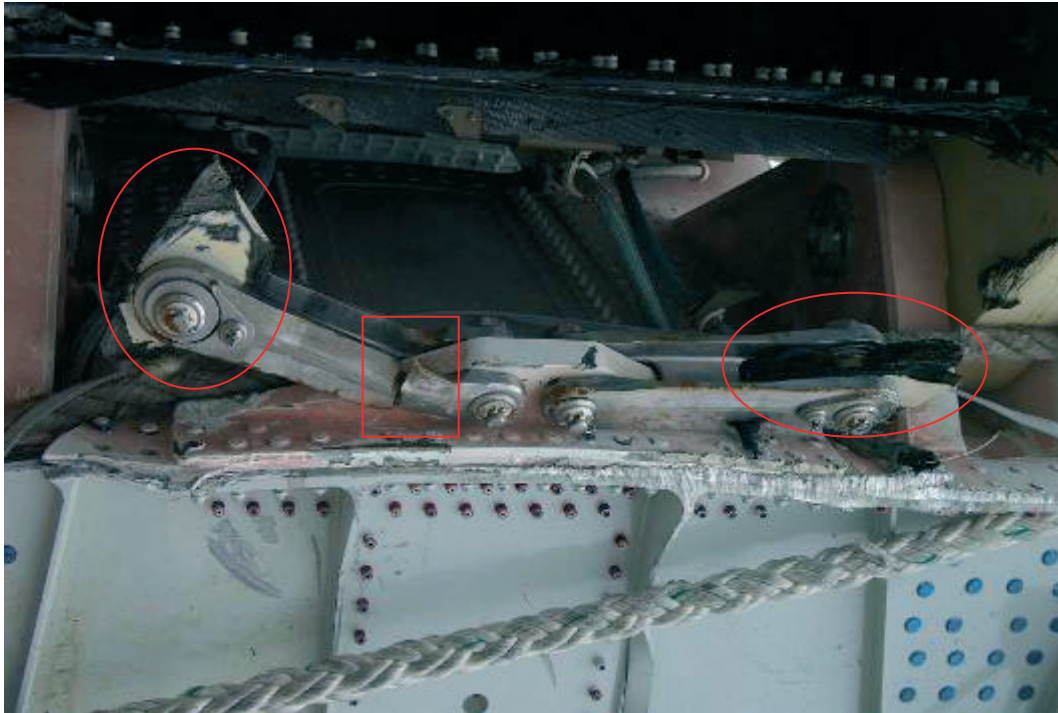
- ❑ tensile failure of the centre spar at the level of the centre rod attachments;
- ❑ compression failure of the aft spar at the level of the aft rod attachments and failure of the left-hand rod by buckling.

Compression failure of the aft spar at the level of the attachments of the lateral load pick-up rods and failure of the left-hand rod by buckling
