Final Report

On the accident on **1st June 2009**
to the **Airbus A330-203**
registered **F-GZCP**
operated by **Air France**
flight AF 447 Rio de Janeiro - Paris

Bureau d'Enquêtes et d'Analyses
pour la sécurité de l'aviation civile

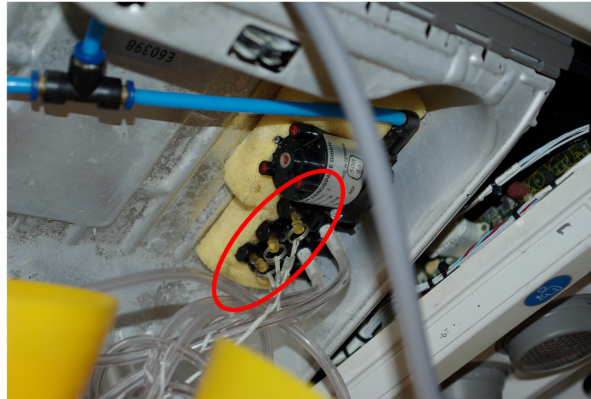
In normal operation, the oxygen is sent to the mask when the passenger releases the system's lock-pin by pulling on the mask. Several pins were found in place, closing the oxygen circuit.

Figure 41: Passenger oxygen container recovered open: the three pins are in place

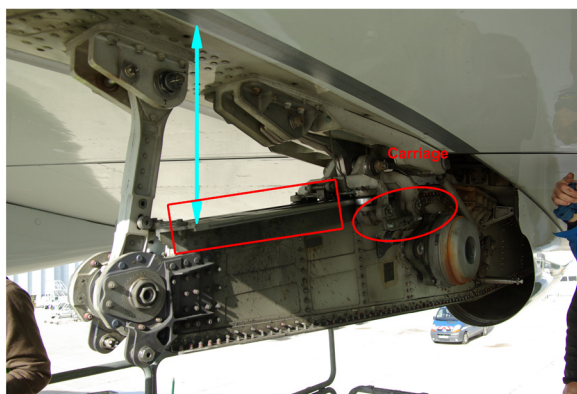
Several parts of the flap extension mechanism fairing were found. There were marks on two of them (positioned at the level of flap track N°3), made by the flap extension track on impact. Analysis of these marks (morphological and dimensional examinations) and comparison with an identical aeroplane made it possible to determine that the flaps were in the “retracted” position (see photo below) at the time of impact with the water (measurement of the distance between the track and the lower surface of the flap, position of the carriage on the track).

Figure 42: Flap extension mechanism (or flap track) No. 3 in retracted position

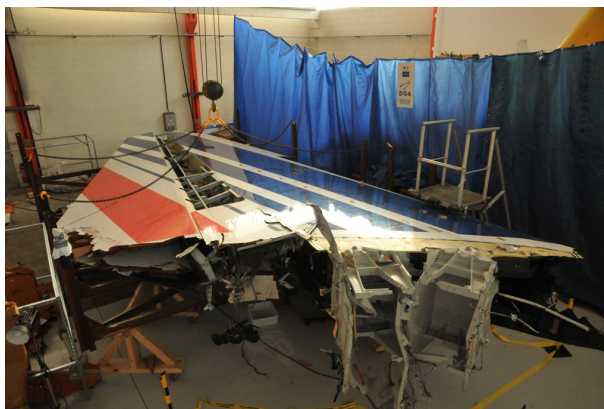
- ❑ The forward attachment (male and female lugs) and the lower part of the side panels (lug reinforcements) were missing;
- ❑ The centre and aft attachments were present: male and female lugs and parts of the fuselage frames.

Figure 44: Fin – In the foreground the base of the fin with the central and forward attachment lugs

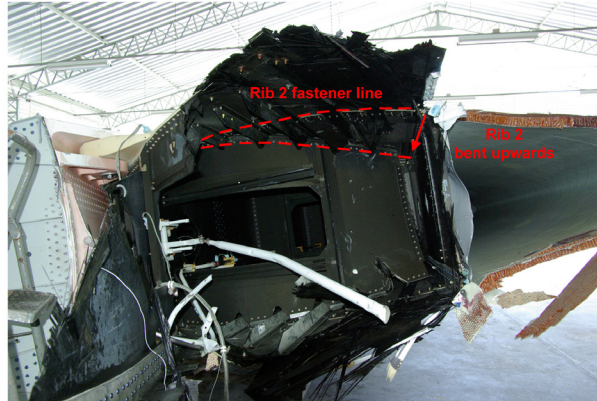
- ❑ Failure of the leading edge right- and left-hand panels
- ❑ Longitudinal cracking of the leading edge stiffener
- ❑ HF antenna support (attached to the forward spar): failure of the lower part, crumpling indicating bottom-upwards compression loads.

Figure 45: Rib 2 bent upwards as a result of bottom-upwards compression loads

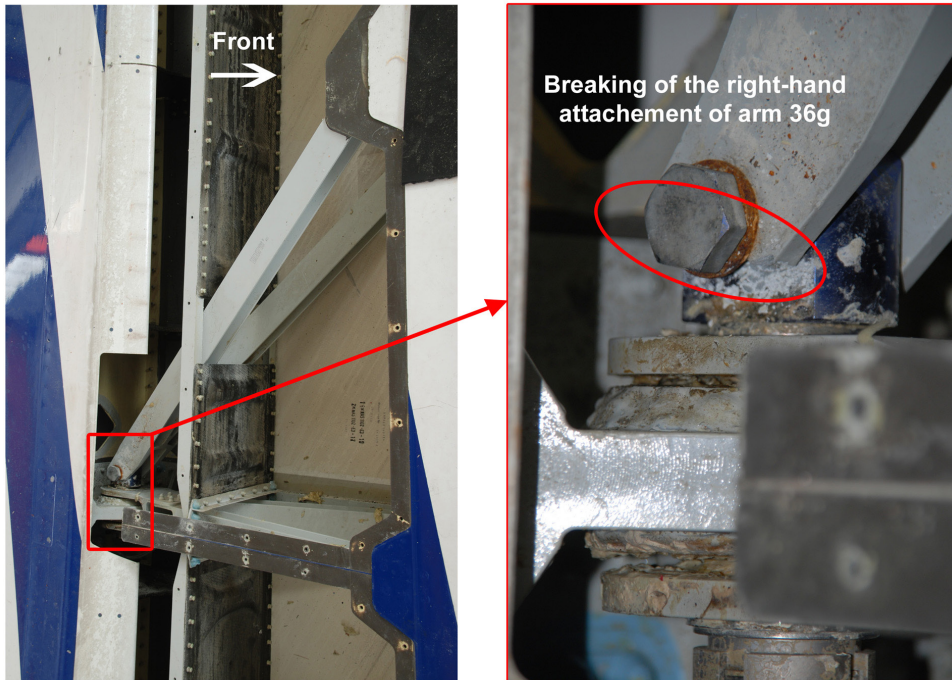
The size of this arm is calculated to withstand a maximum load of 120,000 N, corresponding to a relative acceleration of 36G of the rudder in relation to the vertical stabilizer.

Figure 47: Arm 36G, right view: failure of the rudder attachments

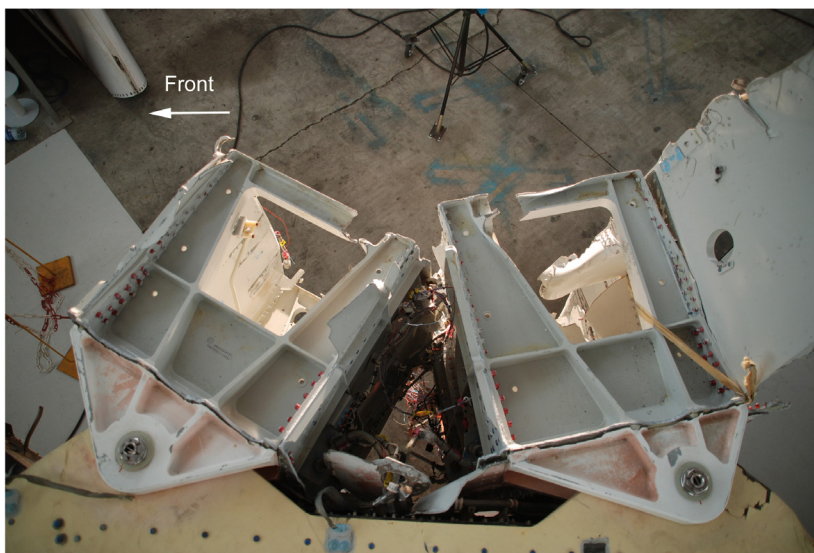
The centre attachment had pivoted backwards with the parts of the frames and web frames that were attached to it. The aft attachment had pivoted forwards with the parts of the frames and web frames that were attached to it.

Figure 51: Fin centre and aft attachments

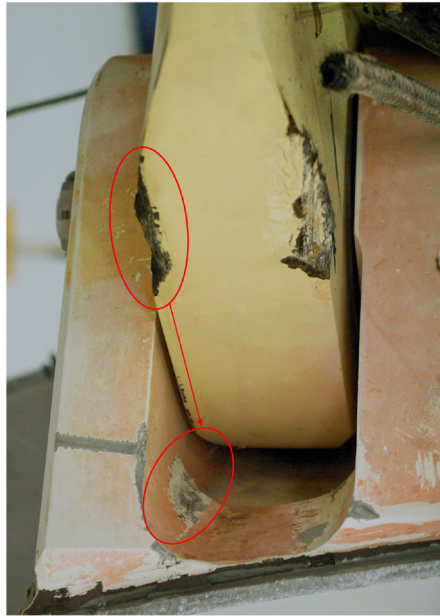
The aft attachment lugs (male on the fin and female on the airframe) had marks indicating a backwards movement of frames 86 and 87 as a whole.

Figure 52: Rear view of the left-hand aft lug: there were marks showing a backwards pivoting of frames 86 and 87

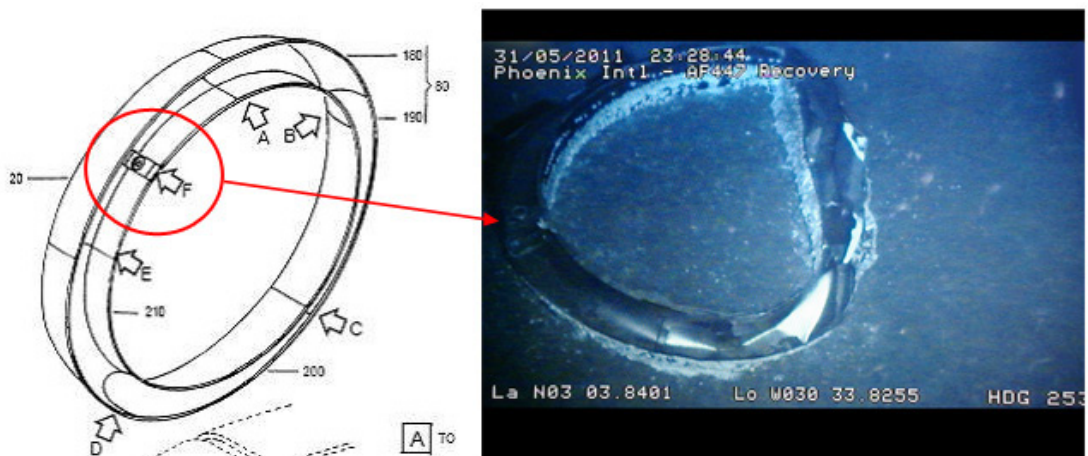
The left engine air entry leading edge had significant deformation on its lower part.

Figure 57: Left engine air intake
