Final Report

On the accident on **1st June 2009**
to the **Airbus A330-203**
registered **F-GZCP**
operated by **Air France**
flight AF 447 Rio de Janeiro - Paris

Bureau d'Enquêtes et d'Analyses
pour la sécurité de l'aviation civile

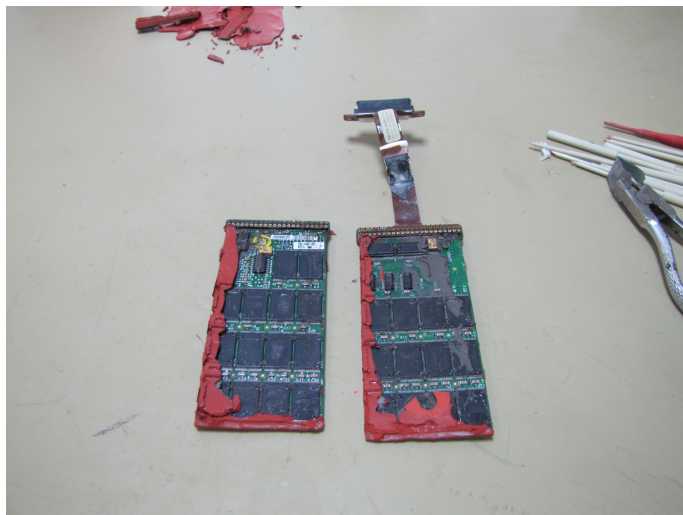
Figure 23: CVR memory boards before cleaning

Visual inspection of the boards revealed damage: a capacitor and a resistor were cracked on one of the boards; two decoder-type components were damaged on the other board.

The boards were placed in an oven for 42 hours. The damaged components were unsoldered and replaced. The impedance value measured at the input connector complied with the measurements made on reference boards. The memory boards were then connected separately to the BEA's memory reader. A few memory components selected previously were addressed and read entirely. The consistency of the binary contents of each memory could then be checked using the manufacturer's hardware and software. The boards were then connected to the BEA's chassis and the data was extracted and decompressed using the manufacturer's official hardware.

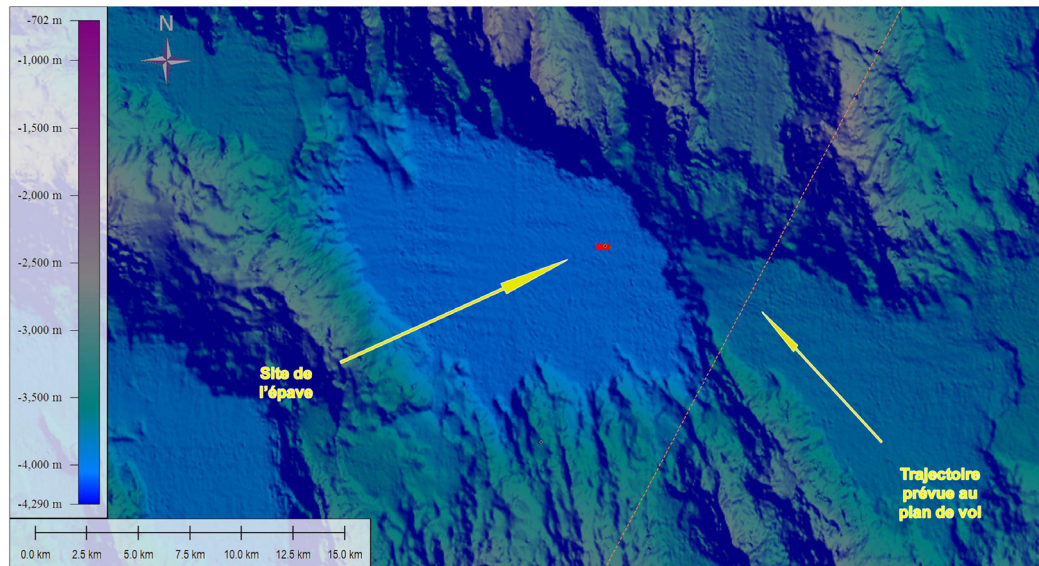
Figure 32: Wreckage localisation

The aeroplane wreckage was found about 6.5 NM on the radial 019 from the last known position, slightly to the left of the planned route. The wreckage rested on an abyssal plain at a depth of 3,900 metres. This plain, surrounded by terrain, made of clay type sediment, was around 15 km wide and was located west of the scheduled aeroplane flight path.

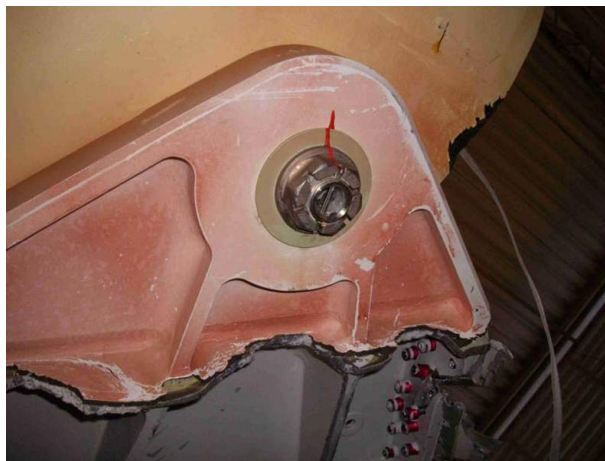
Figure 49: Right-hand aft lug: shearing of the fuselage along main frames 86-87

The part of frame 87 that can be seen had undergone S-shaped deformation: the left-hand side forwards, and the right-hand side backwards. The horizontal stabiliser actuator supports were deformed and broke in a backwards movement from the front. These observations indicate a backwards movement of the trimmable horizontal stabiliser.

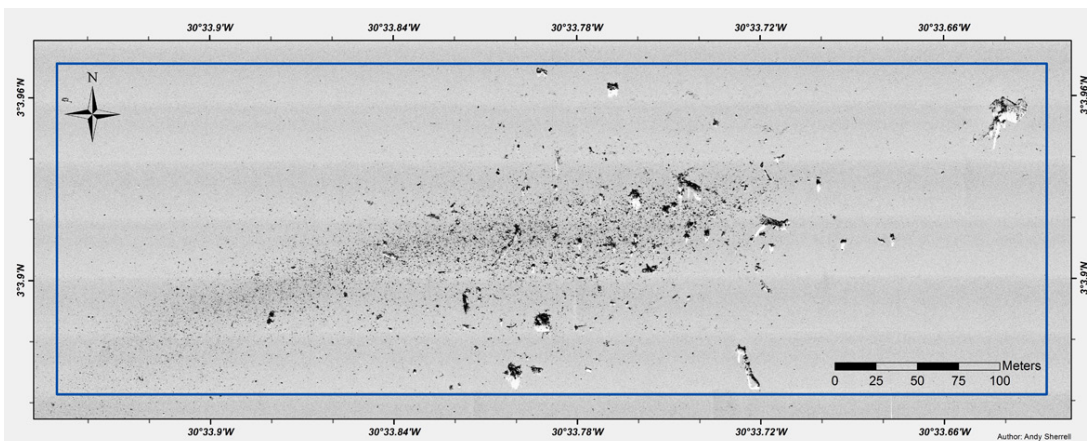
The densest debris (central section, engines, APU, landing gear) was found to the east of the site and the lighter debris to the west.

Outside the main area of 600 metres by 200 metres, a rear left fuselage panel containing eleven windows and around seven metres long was found approximately two kilometres south-west of the area. Part of the lower surface of the trimmable horizontal stabiliser was also found slightly to the south-west of this area.

Figure 55: Sonar Images of the debris field

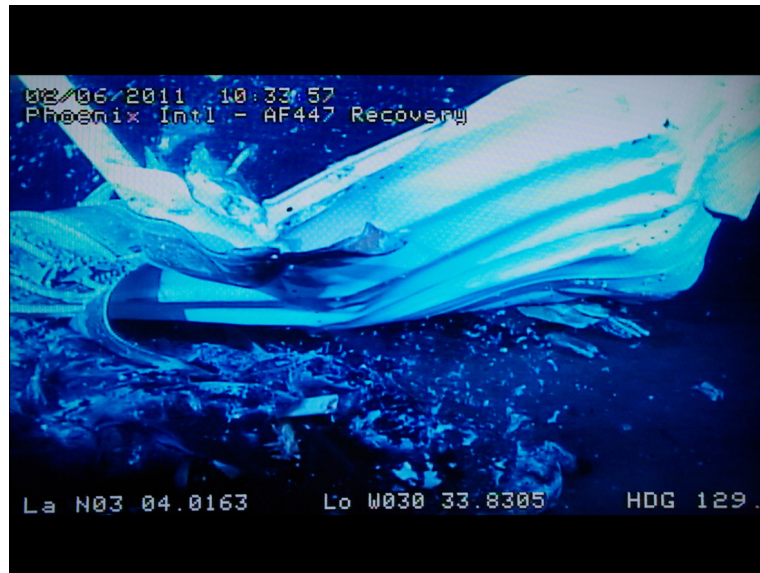
The lower elements of the fuselage were badly broken up and deformed. In these areas, crushing of the sheet-metal between the ribbing was noted, which indicates a vertical component at the time of impact.

Figure 56: Parts of the fuselage

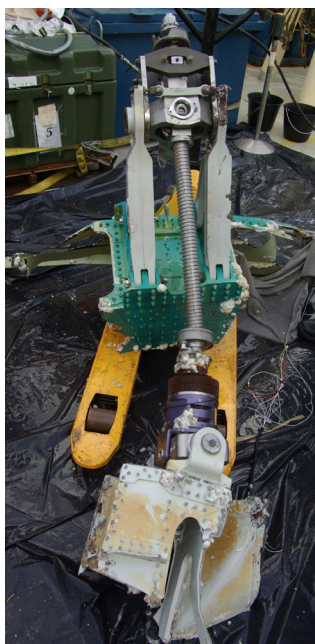
According to the manufacturer's technical documentation, the relative position of the actuator and the THS screwjack corresponded to a THS position of between 13° and 13.5° nose-up.

Figure 61: Trimmable horizontal stabiliser screwjack after being raised on board

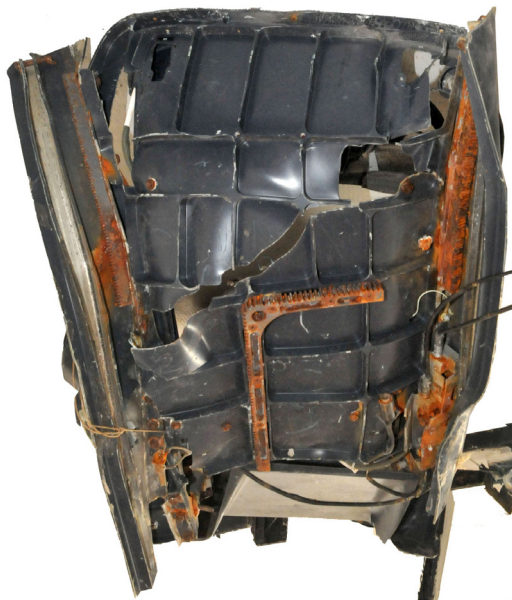
The marks left by the adjustment mechanism under the seat cushion enabled the horizontal position of the seat on impact to be determined. The seat was positioned 5.5 cm from the most forward position.

Figure 81: Right side seat cushion

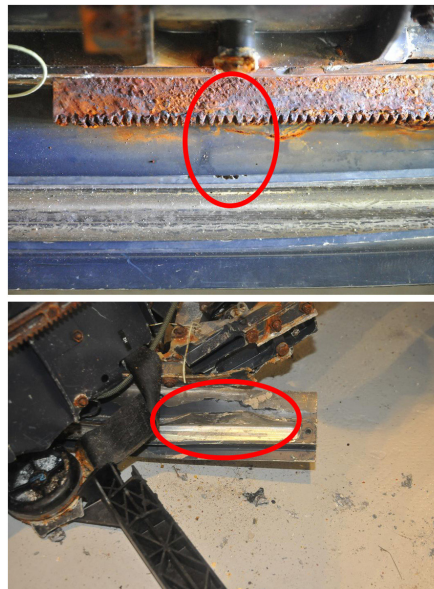
Figure 82: Marks on the adjustment mechanism

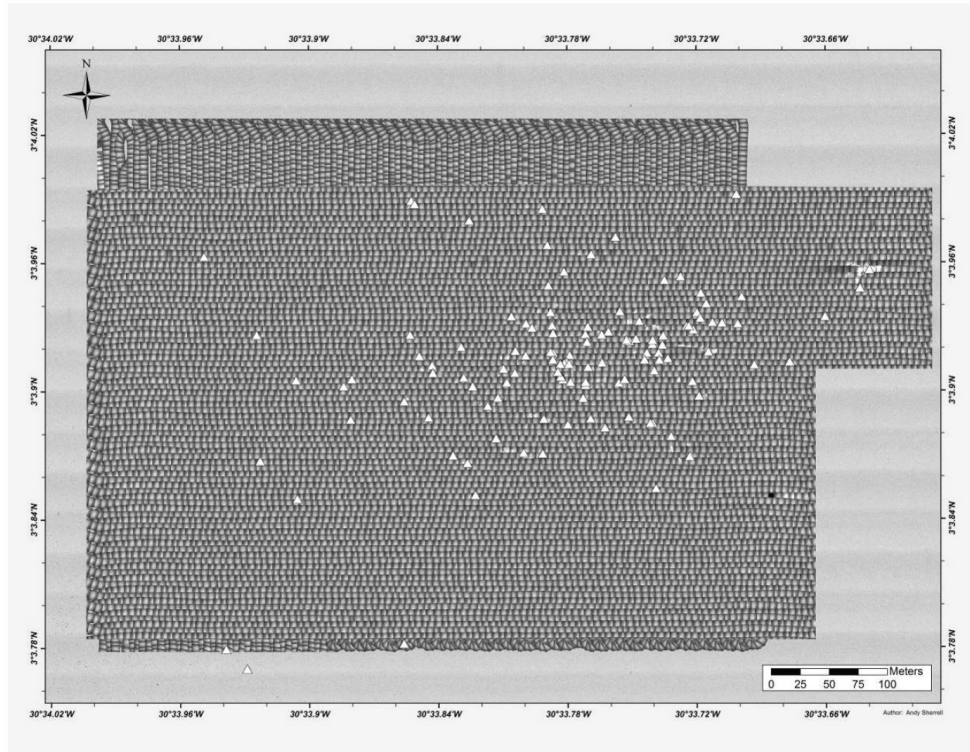
Figure 98: Visualisation of the photo mosaic obtained with REMUS AUV images and the aeroplane debris identified by using the REMORA ROV

The resources used during phase 4 helped the BEA to save a considerable amount of time in the following phase, especially the photos of the wreckage. The investigators thus had a complete two-dimensional representation of the crash site based on high resolution side-scan sonar images and photos before working on site with an ROV. These photos proved very useful for both preparing phase 5 and then conducting operations on site. They would have provided even more information if they had been in colour.
